**ADDENDUM NO. 2
December 15, 2023**

**Red Hill Water Treatment Plant - Upgrades
IFB No. 403
Rivanna Sewer & Water Authority
Albemarle County, Virginia**

Report dated September 1, 2017, consisting of 30 pages, prepared by Dixon Engineering, Inc., titled:
Preliminary Maintenance Inspection
10,000 Gallon Hydropneumatic Tank
(Red Hill)

Preliminary Maintenance Inspection
10,000 Gallon Hydropnuematic Tank
(Red Hill)

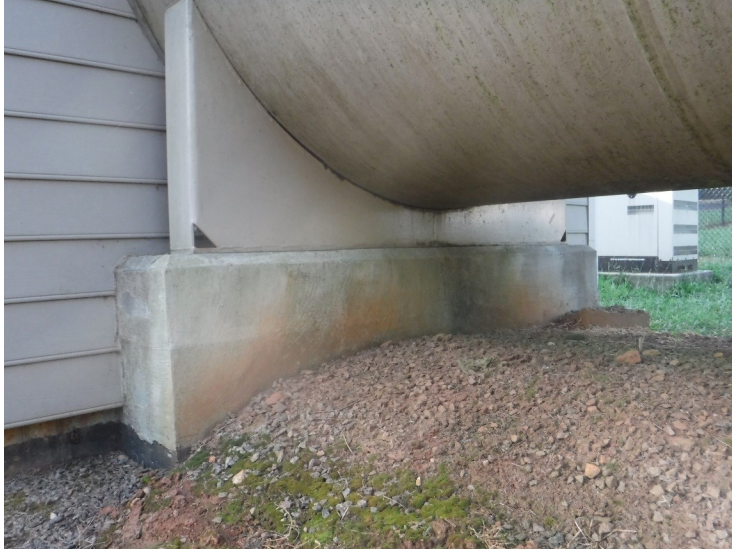
1) Coating on bottom of the tank is in good condition.

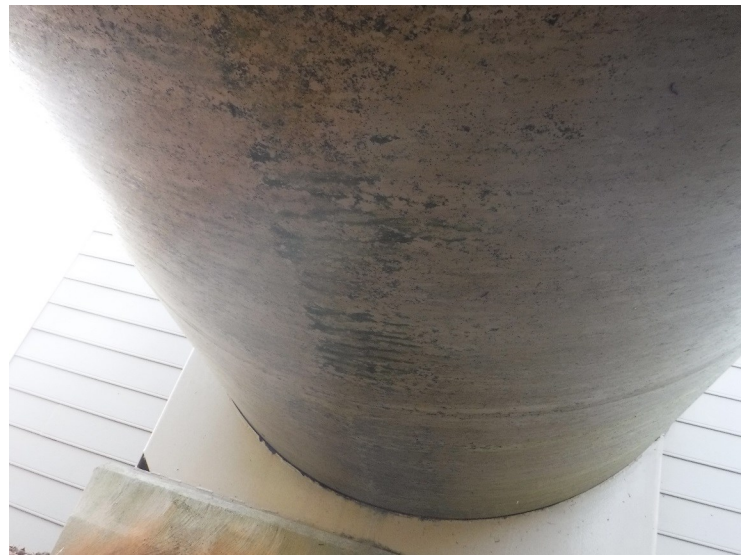
2) Same.

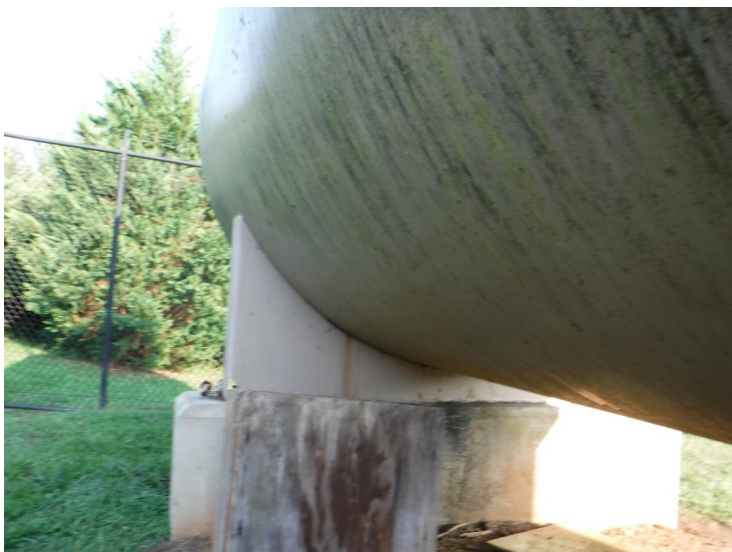
3) Same.

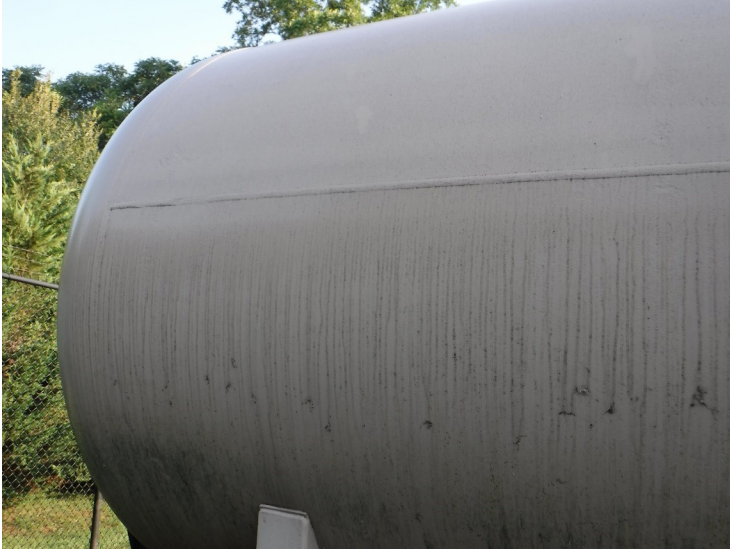
4) The sidewall coating is in good condition.

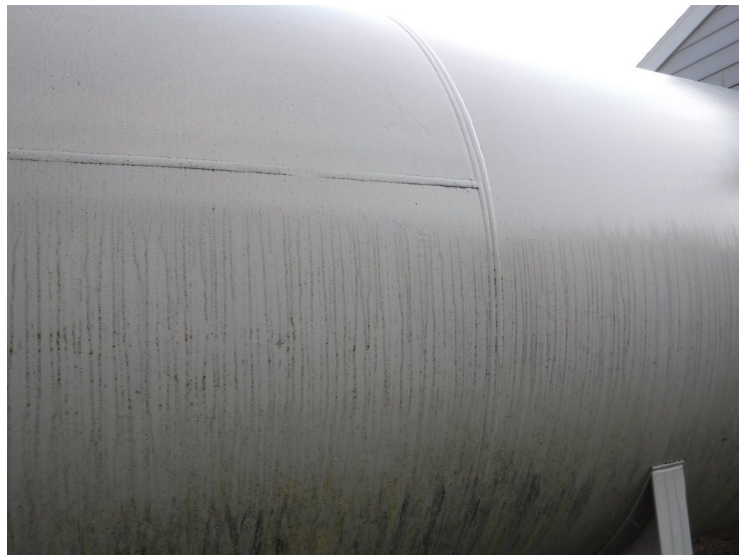
5) Same.

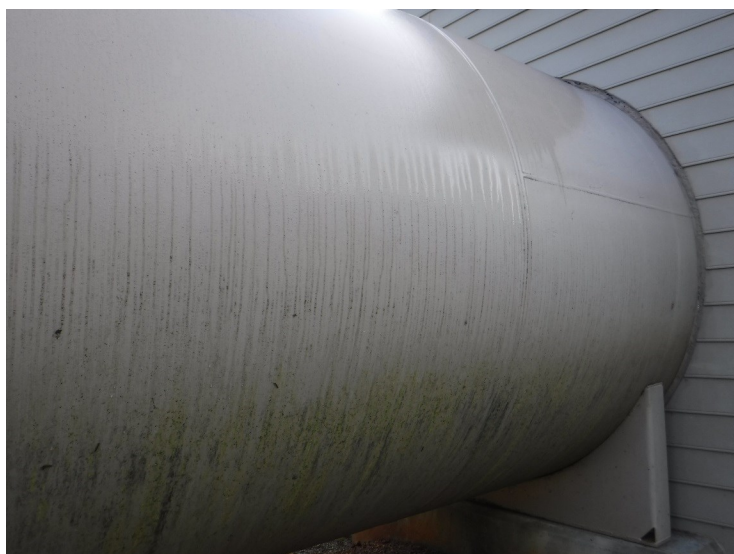
6) Same.

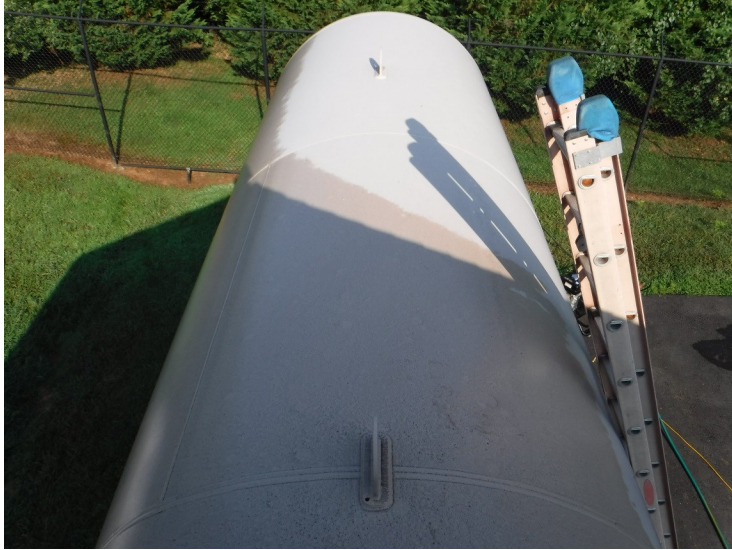
7) The coating on roof is in good condition.

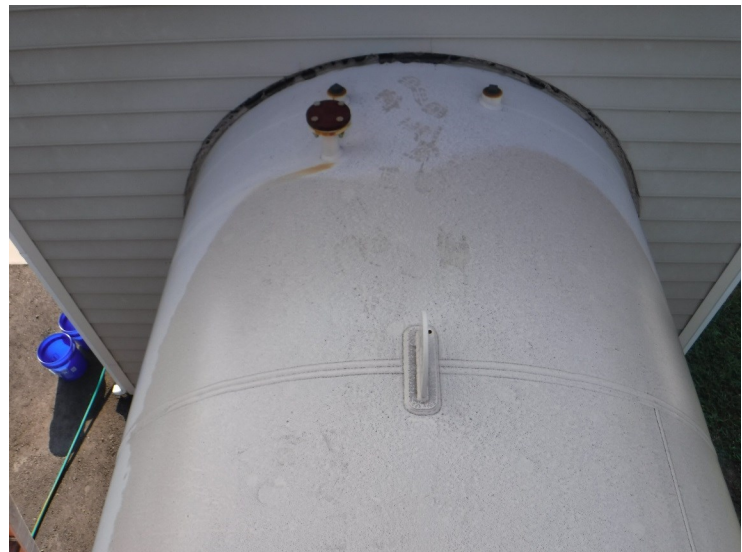
8) Same.

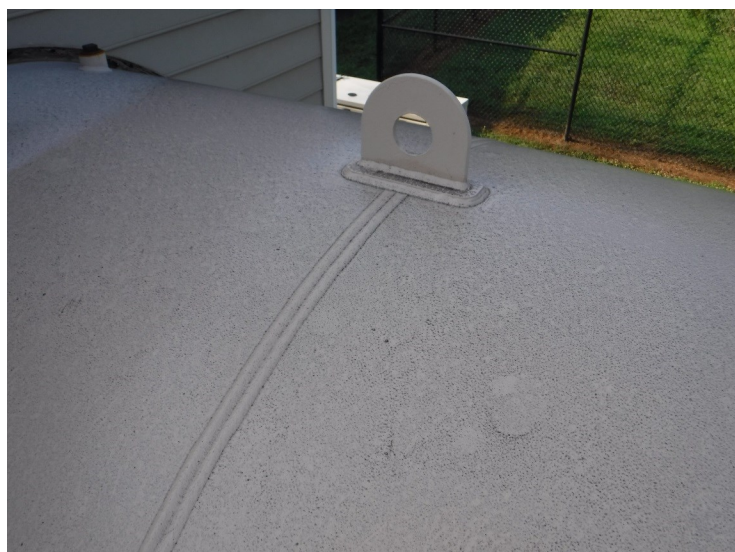
9) Original lifting lugs remain.

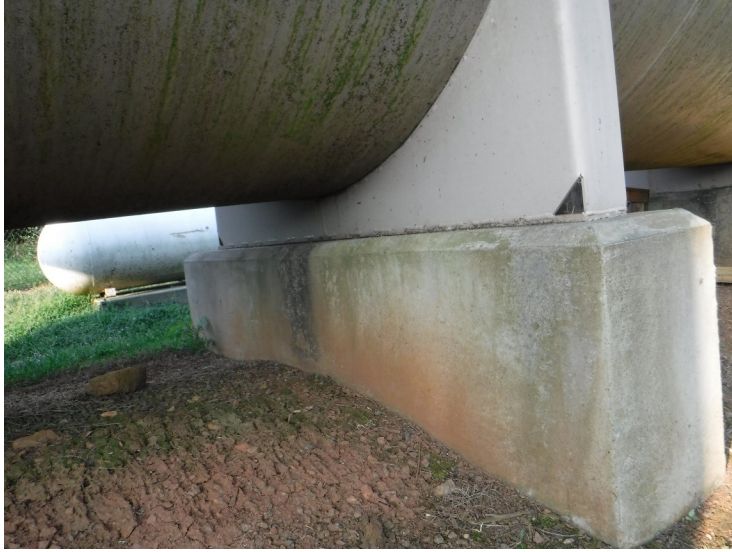
The exposed saddle foundations are in good condition and showed no signs of deterioration. The exposed foundation is not coated.

10) Concrete foundation and steel saddles are in good condition.

Pressure wash and coat the exposed concrete with an epoxy coating system to help prevent deterioration. The cost would be incidental to exterior coating.

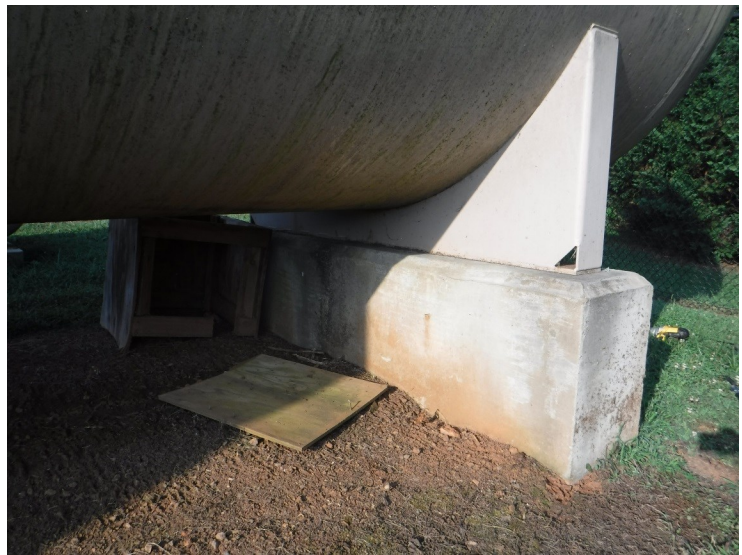
11) Same.

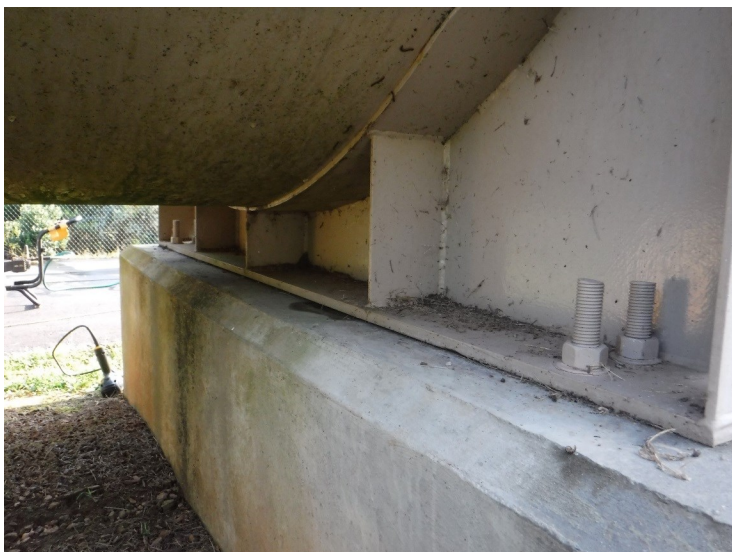
12) Same.

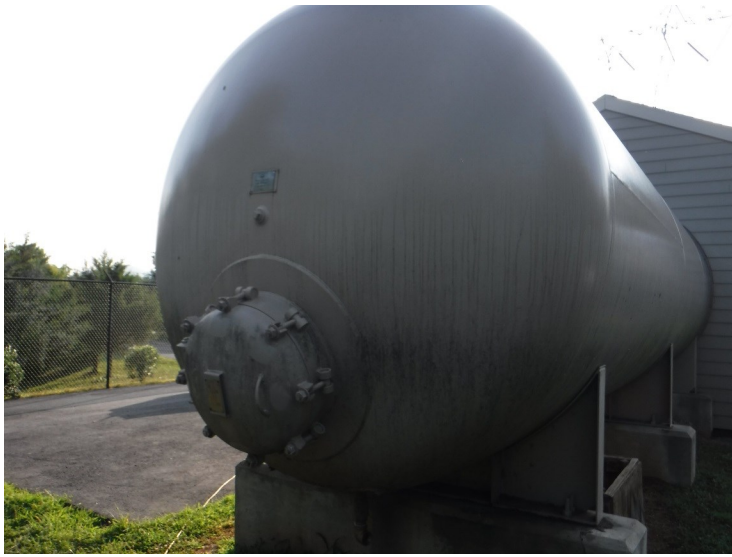
13) The coating on the exterior end cap is in good condition.

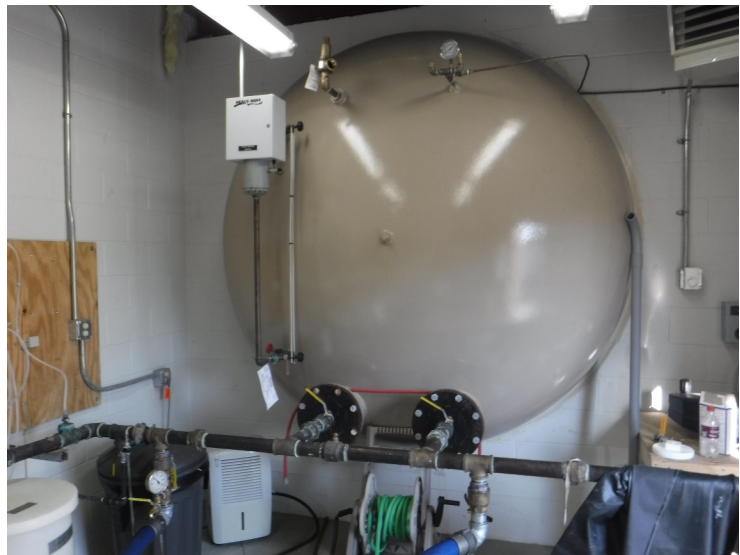
14) Interior end cap coating is in good condition.

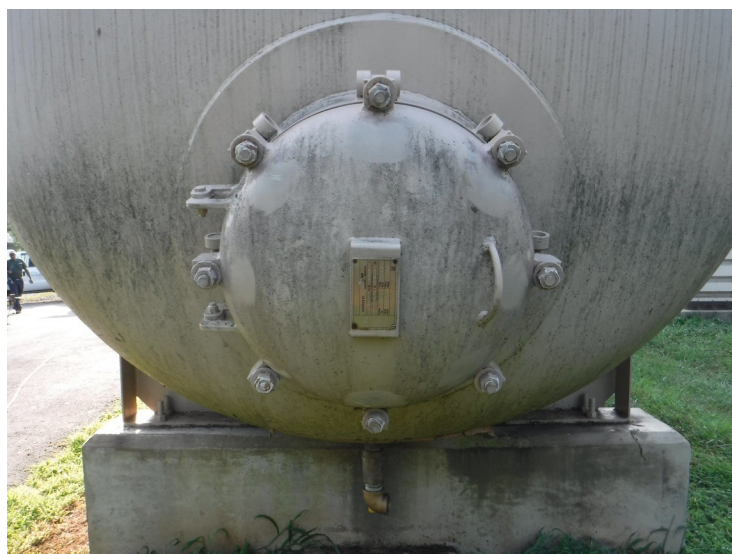
There is a 24 inch diameter bolted manway located in the end cap outside of the building that is in good condition. There were no signs of leakage.

15) Manway to wet interior on exterior endcap.

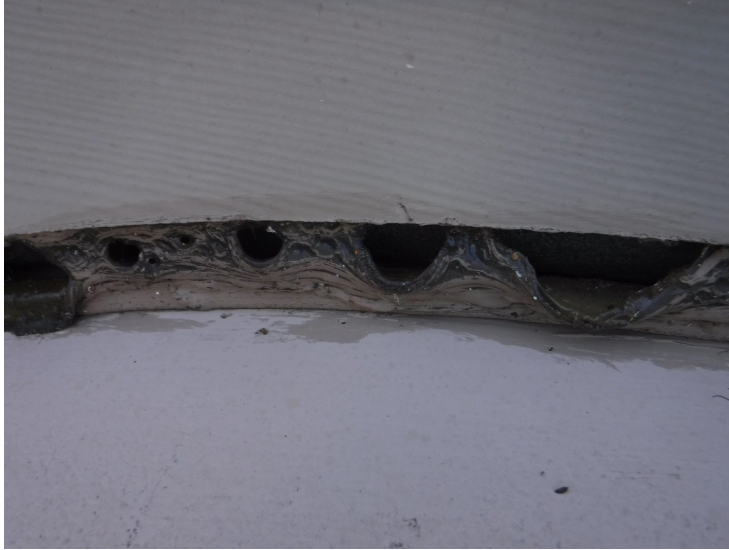
The caulk between the tank and building is in good condition with approximately three total lineal feet missing on the top side.

16) Caulking between the building and the tank is missing on the top.

Repair the caulk by removing all dried and cracked caulk and fill missing areas with new caulking. Cost would be incidental to exterior coating or could be done by in-house personnel.

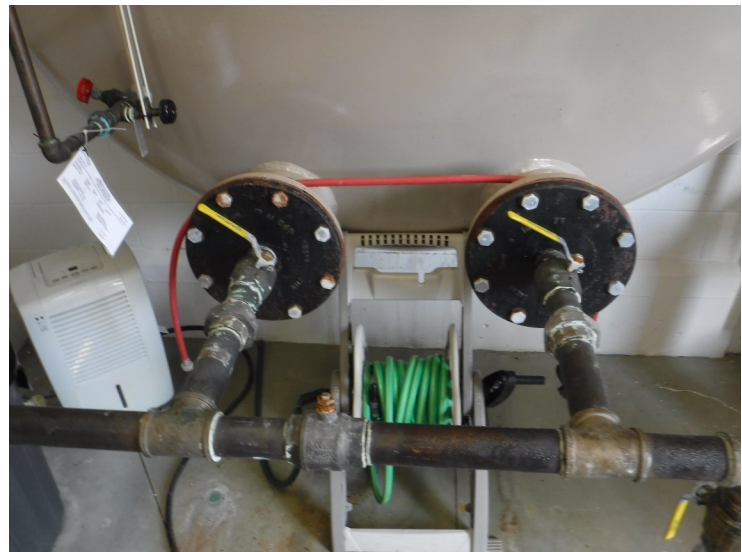
There is piping located inside the control building that enters into the tank. The piping is in good condition. The piping is not coated and the pipes have minor surface rust.

17) Piping inside of building is not coated and has some minor surface rust.

When the interior is repainted, abrasive blast clean the piping to a commercial (SSPC-SP6) condition and apply an epoxy system. The estimated cost is \$3,000.

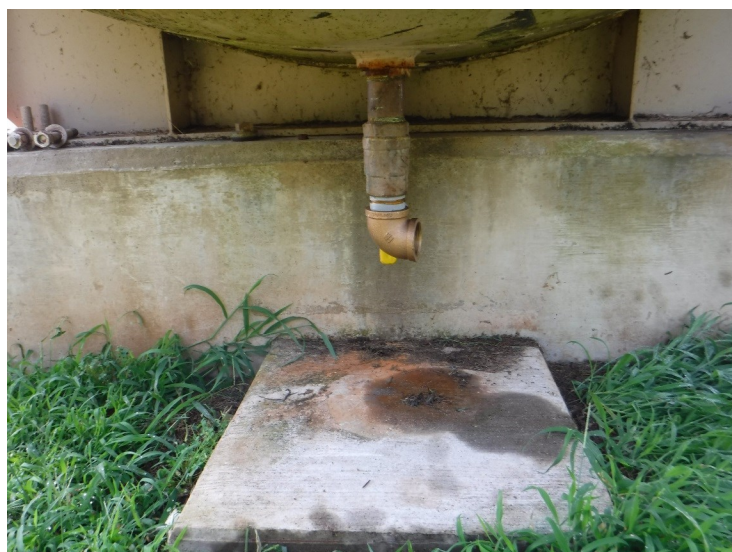
18) Drain line discharges to a concrete splash pad.

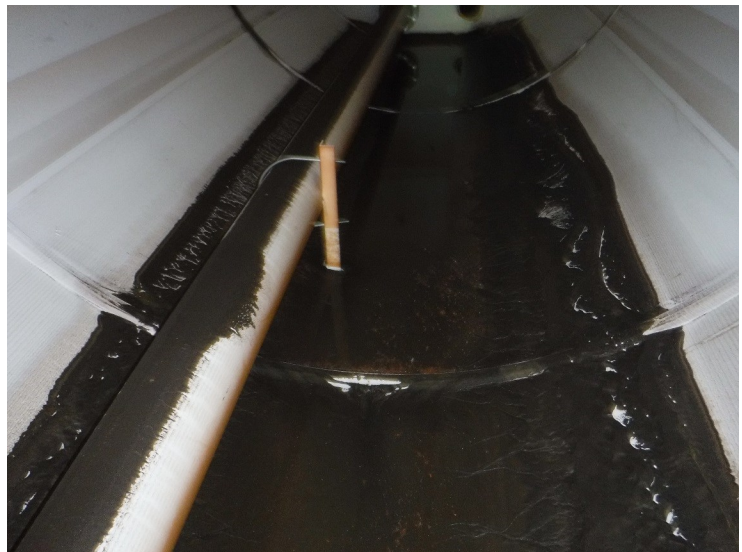
The bottom was covered with approximately ½ inch of sediment that was flushed from the interior.

20) Bottom of tank was covered with sediment.

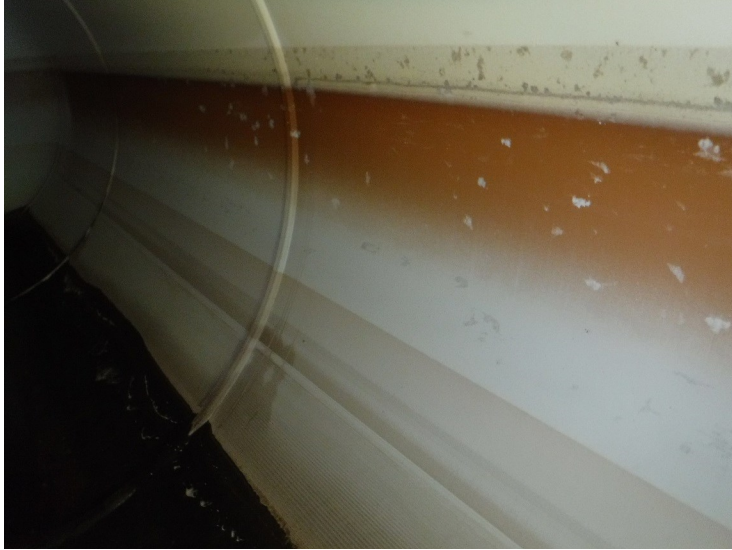
The equator area was covered with moderate mineral staining which does not affect the integrity of the coating system.

22) The sidewall coating is in good condition with mineral staining at the equator.

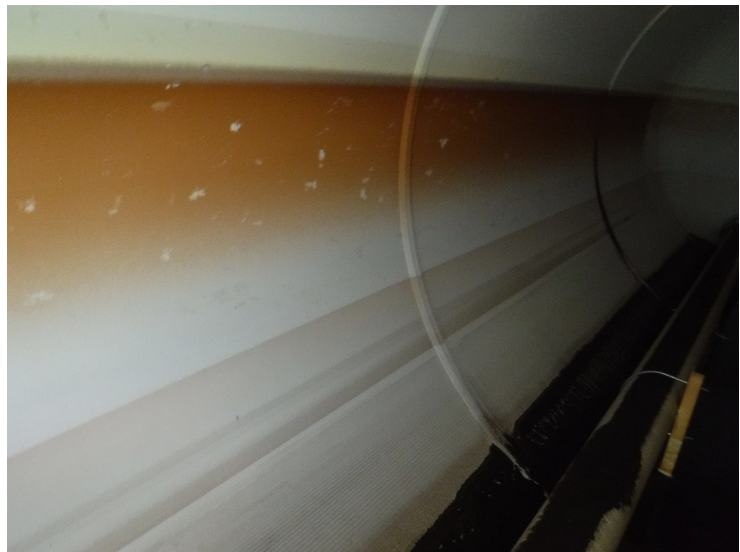
23) Same.

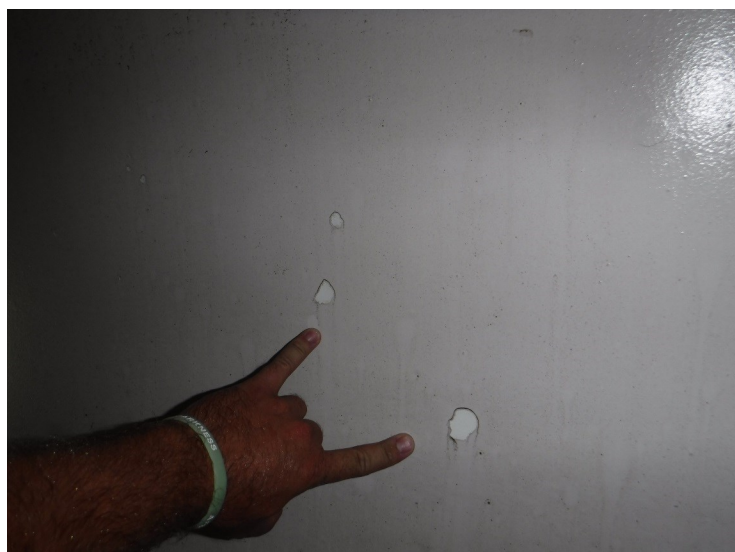
The bottom and sidewall coating is in good condition with deterioration in the form of delaminated topcoat and cracking.

24) Minor topcoat delamination on the sidewall.

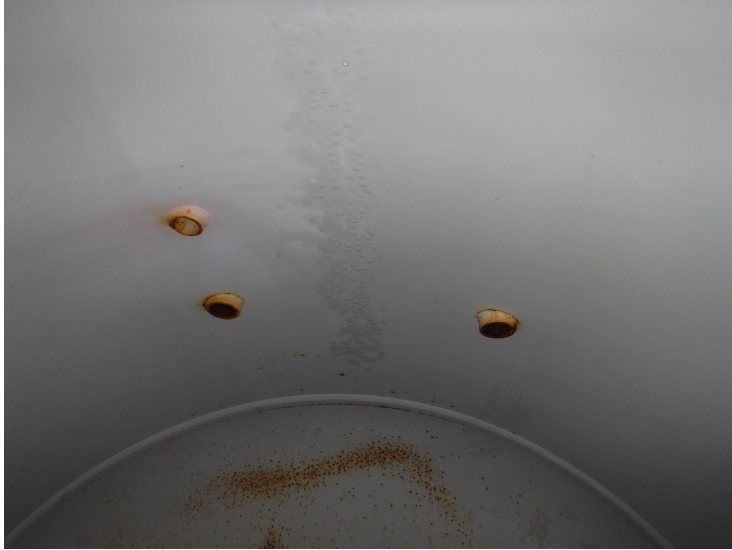
25) The roof coating is in good condition overall with coating failures on roof couplings.

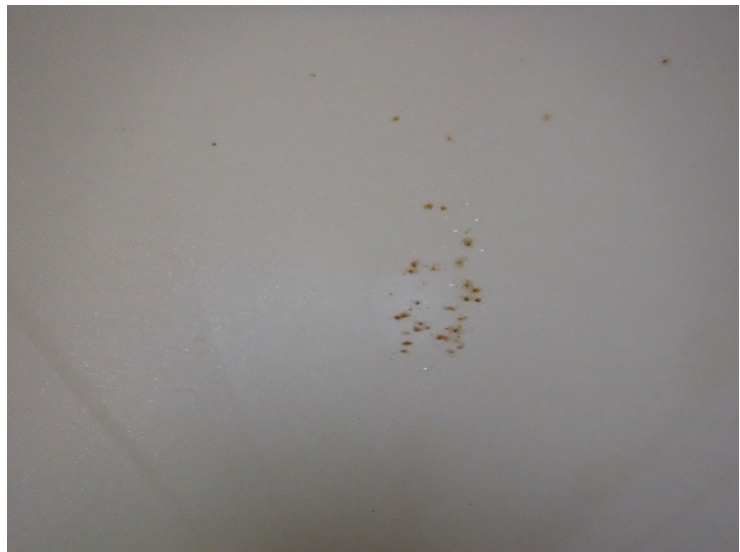
The roof and end cap coating is in good condition with deterioration in the form of rust bleedthrough in a few areas. Minor failures are also present on weld seams and penetrations.

26) Minor rust bleedthrough on the roof.

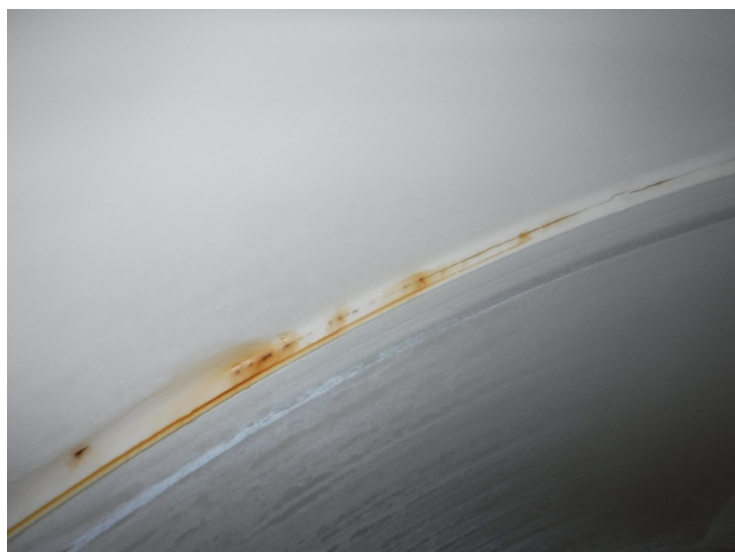
27) Minor rusting at the roof weld seam.

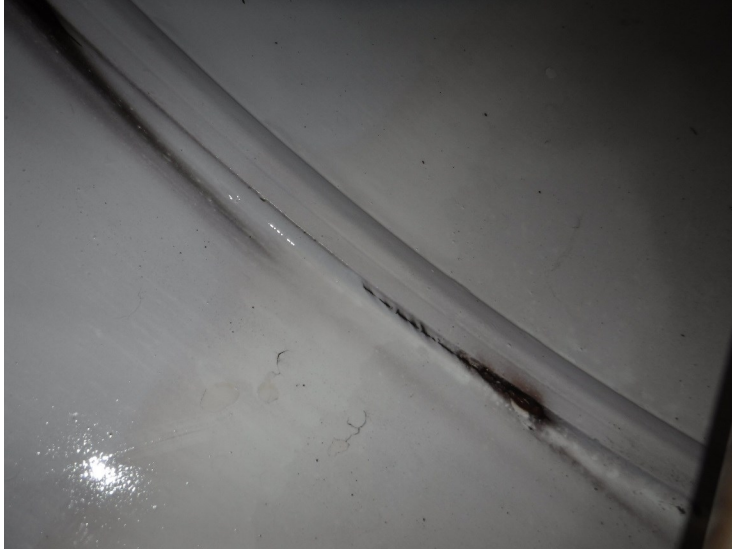
28) The roof coating is in good condition with minor cracking of coating at the weld seams.

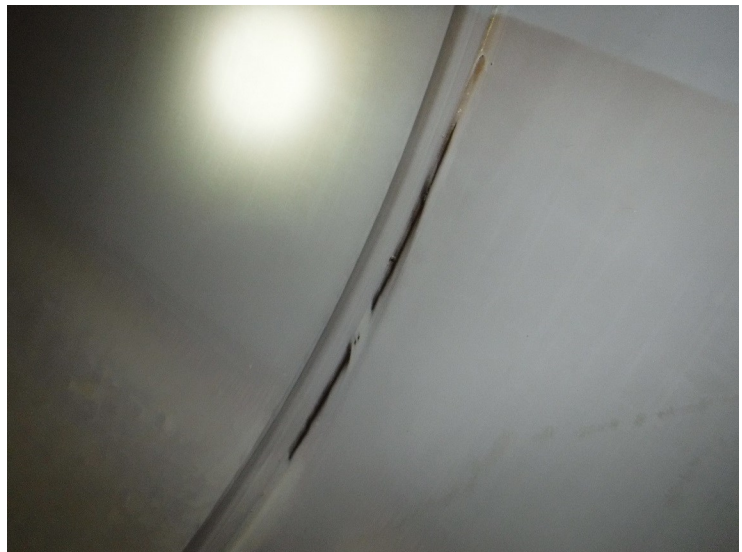
29) Same.

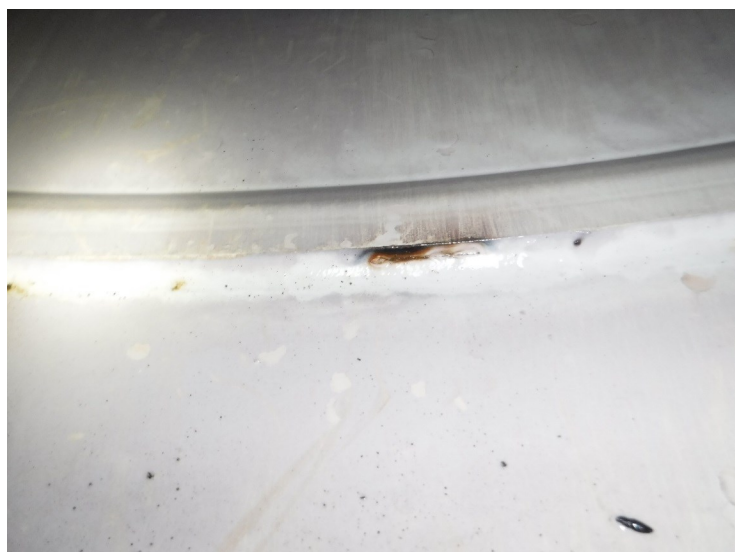
30) Same.

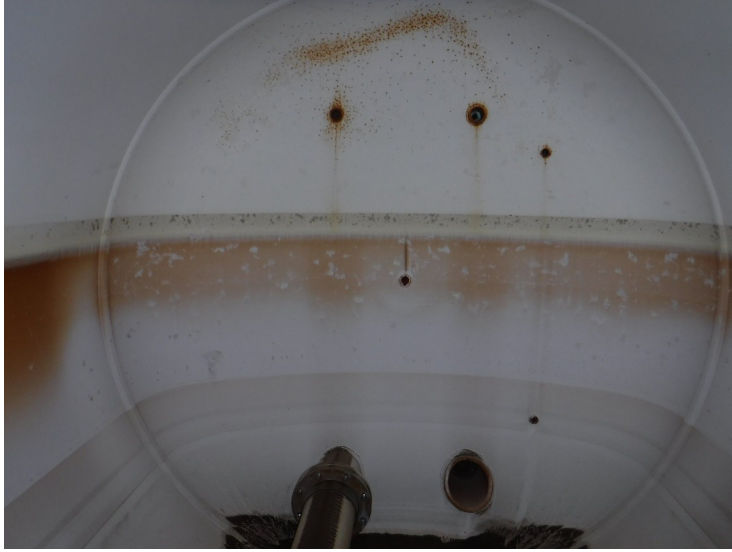
34) Coating on endcap is in good condition with minor rust bleedthrough.

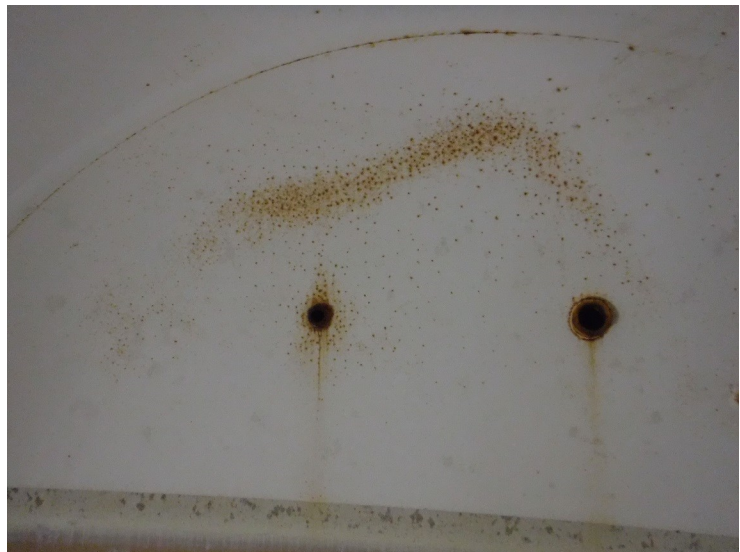
35) View of rust bleedthrough and couplings in the end cap.
