Moore's Creek Advanced Water Resource Recovery Facility Rivanna Pump Station Update

What happened at the Rivanna Pump Station?

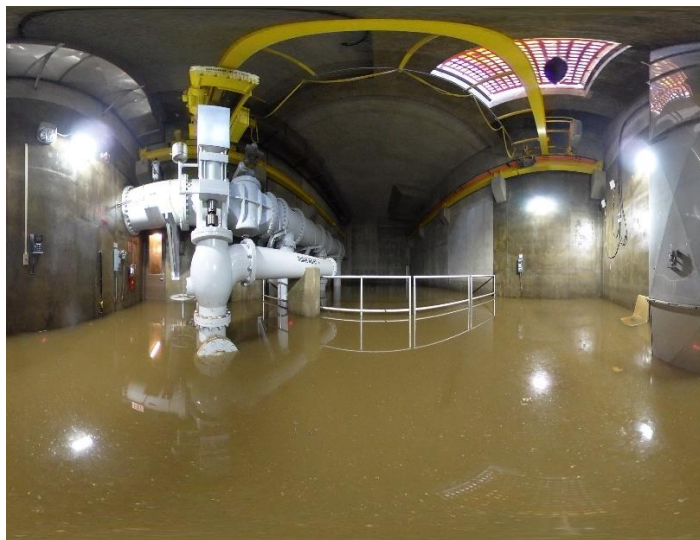
On January 9, 2024, high rain and wastewater flows may have damaged equipment in the Rivanna Pump Station causing it to malfunction, become submerged, and discontinue operations. This resulted in several wastewater overflows from manholes in and around Riverview and Darden Towe parks.

Submerged pump station pump room

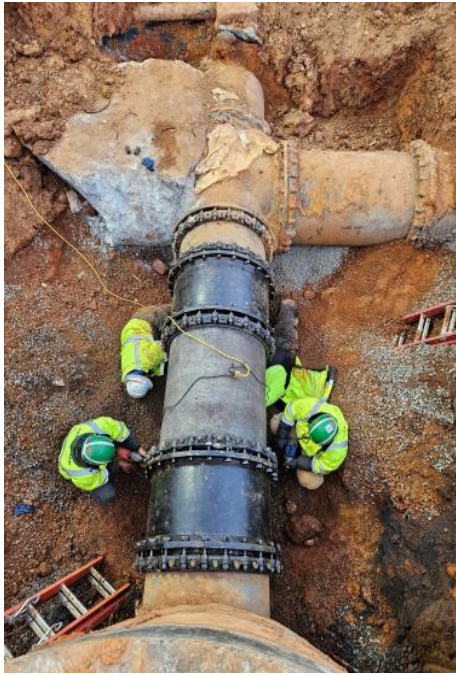
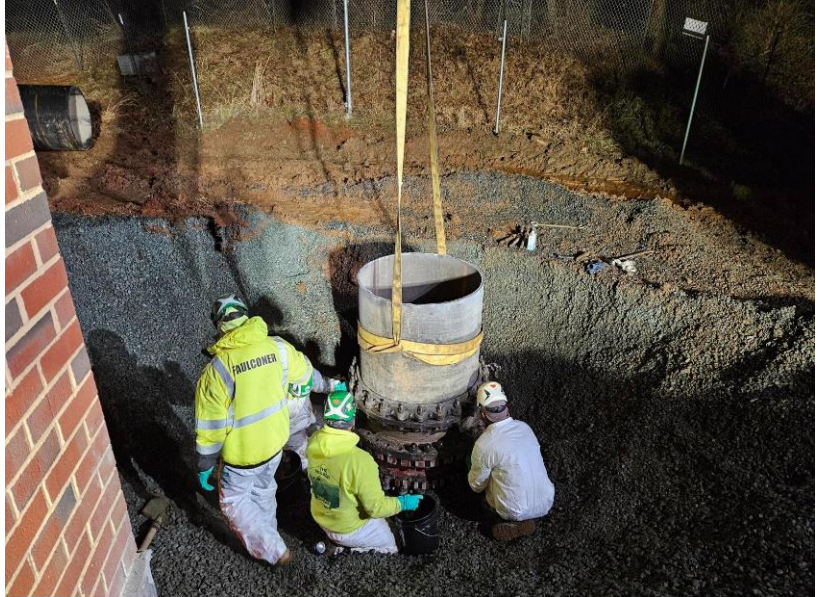
The Rivanna Maintenance team and contractors working on piping connections for the pumping bypass system.

RWSA Maintenance staff and contractors have completed a 50 million gallon per day pumping and piping bypass system that will convey wastewater around the damaged pump station to complete

the normal treatment process. This system will also allow RWSA to manage higher wastewater flows that are received during storm events.

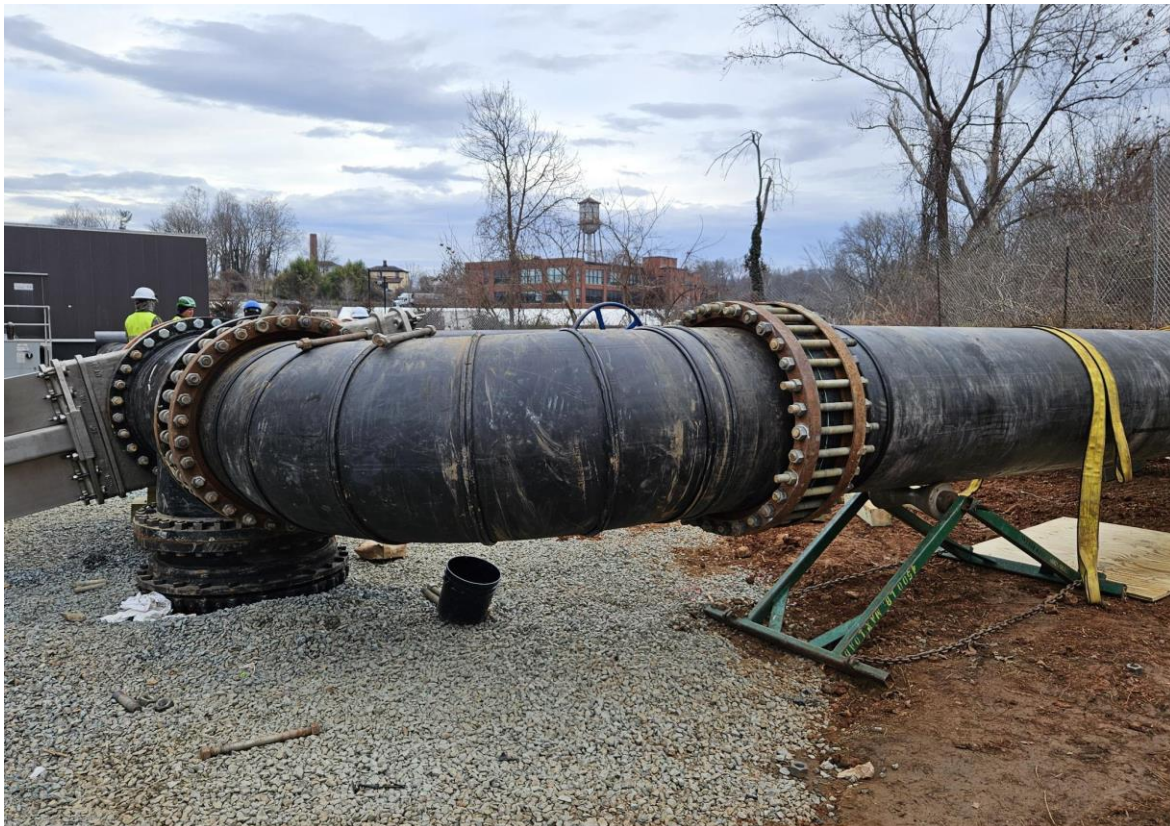
Pumping bypass system

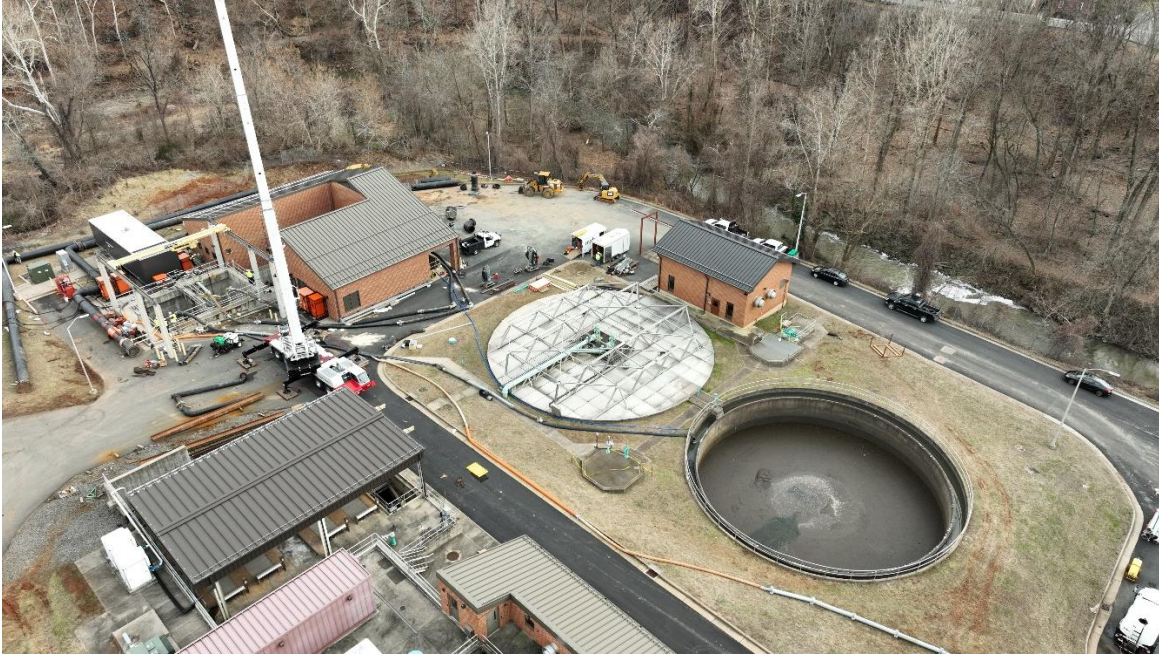
Setting up the 50 million gallon per day bypass system

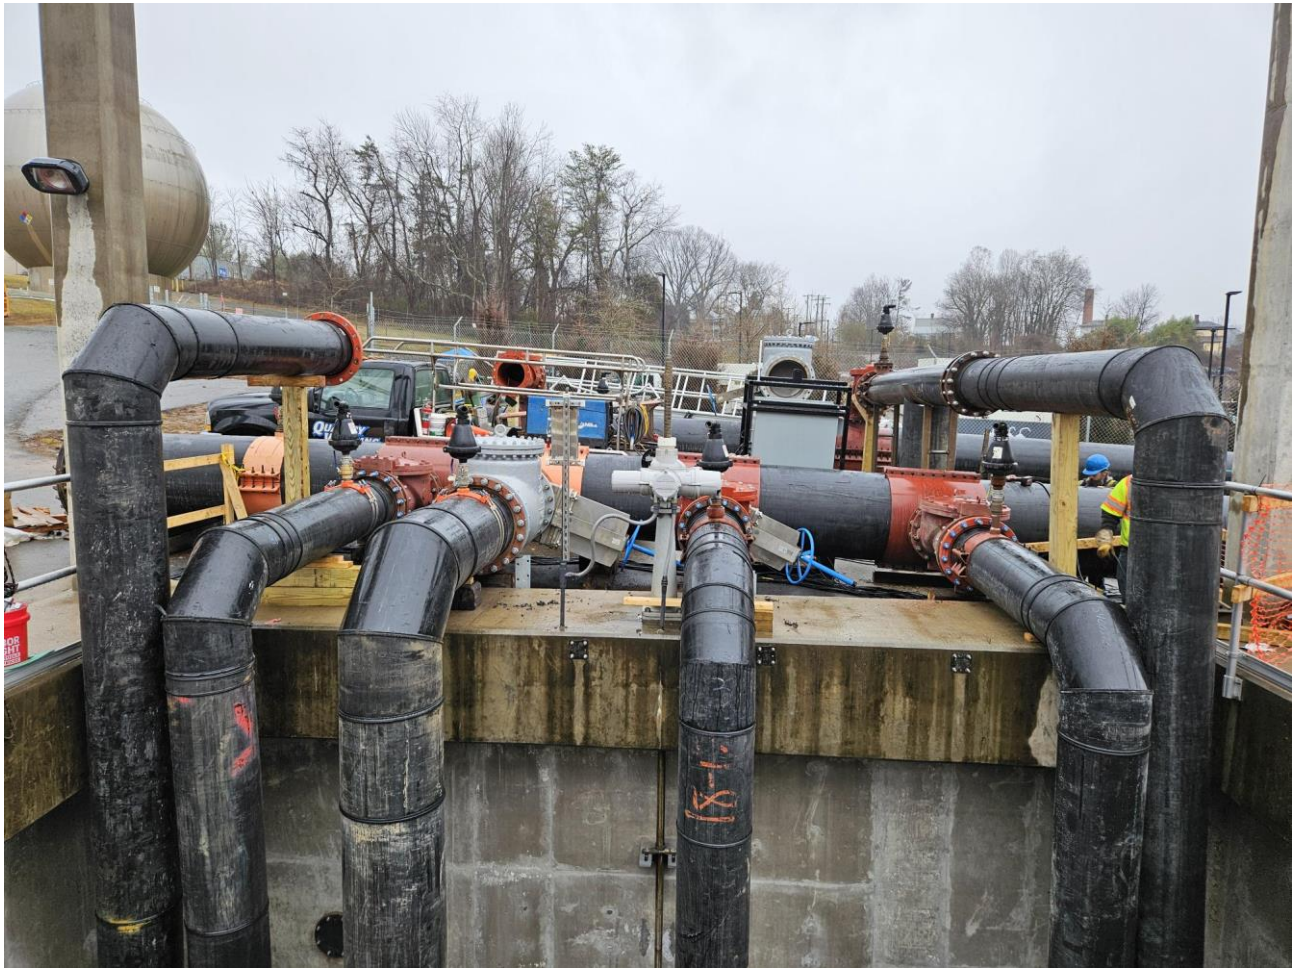
Bypass pumping system

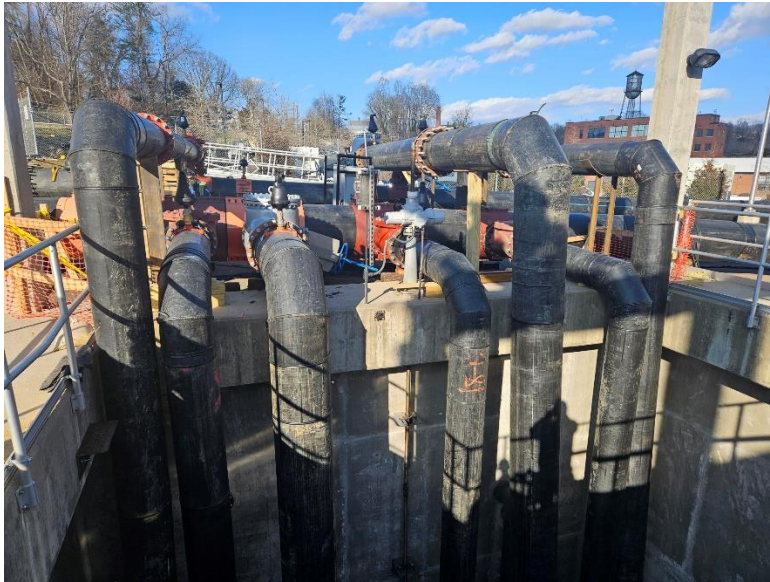
February 14, 2024

Bypass system pipes in the wet well

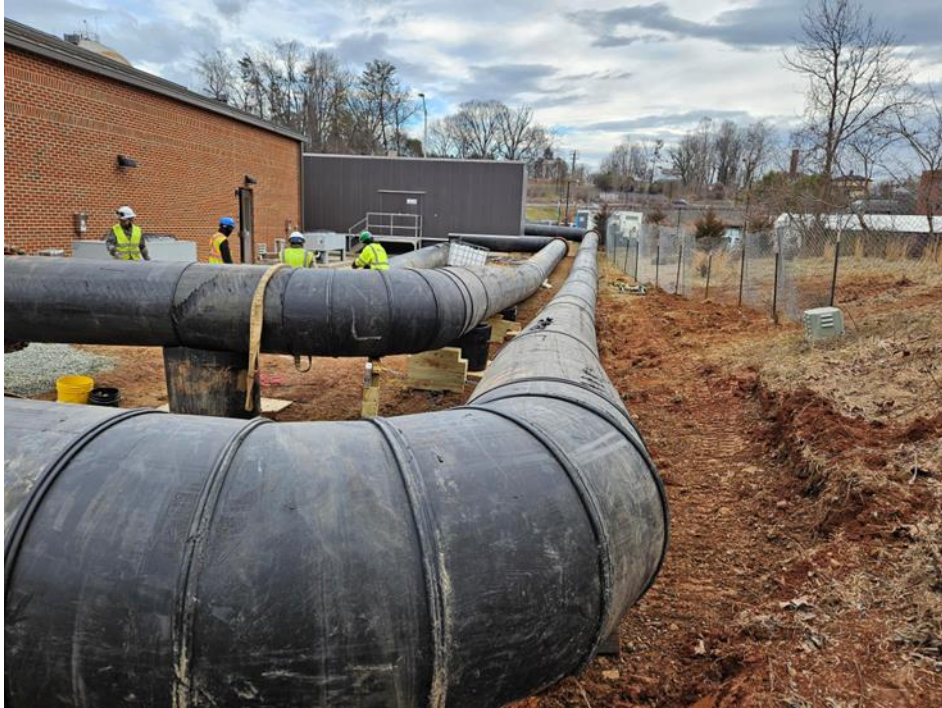
February 9, 2024

Large bypass system pipes

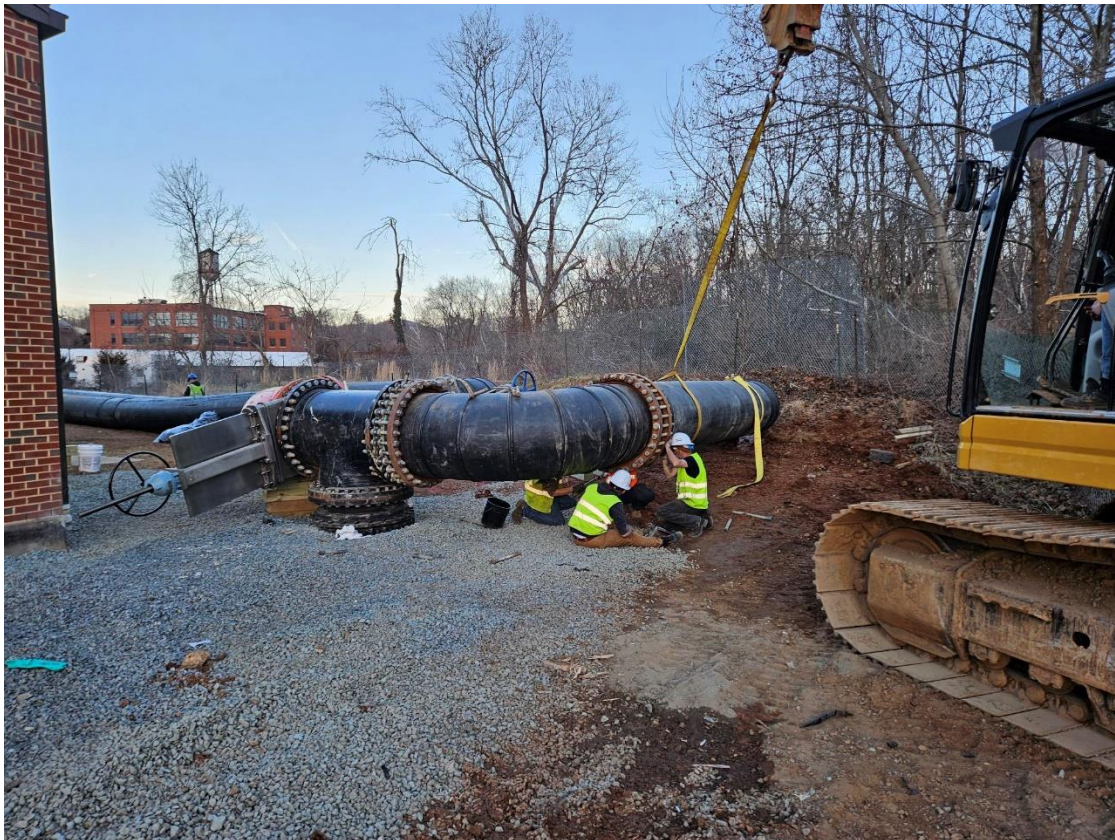
February 8, 2024

Bypass system pipes

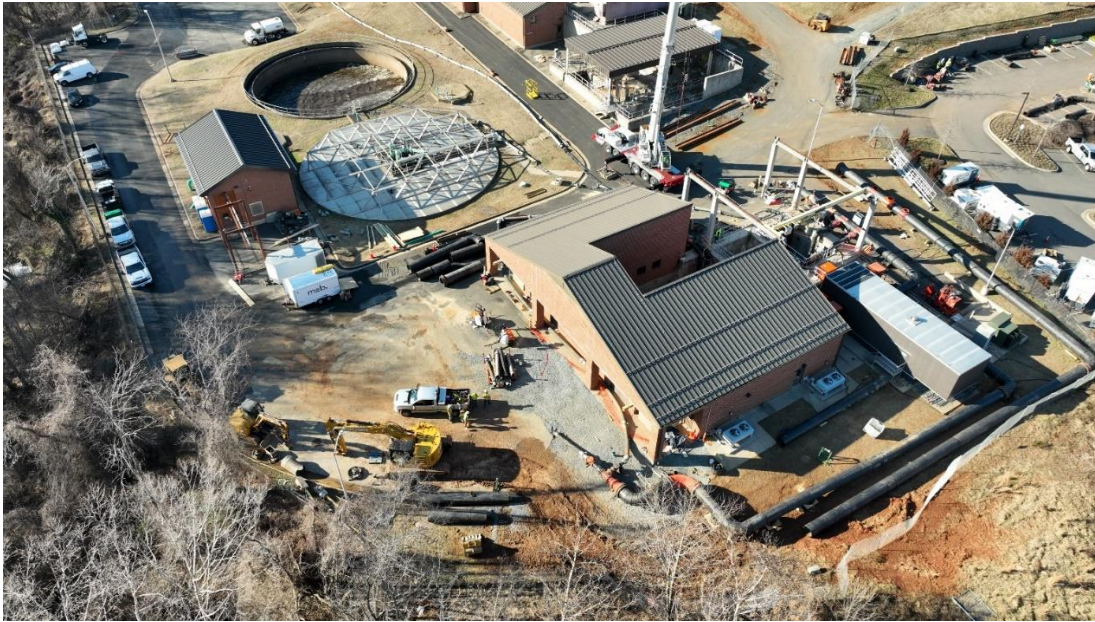
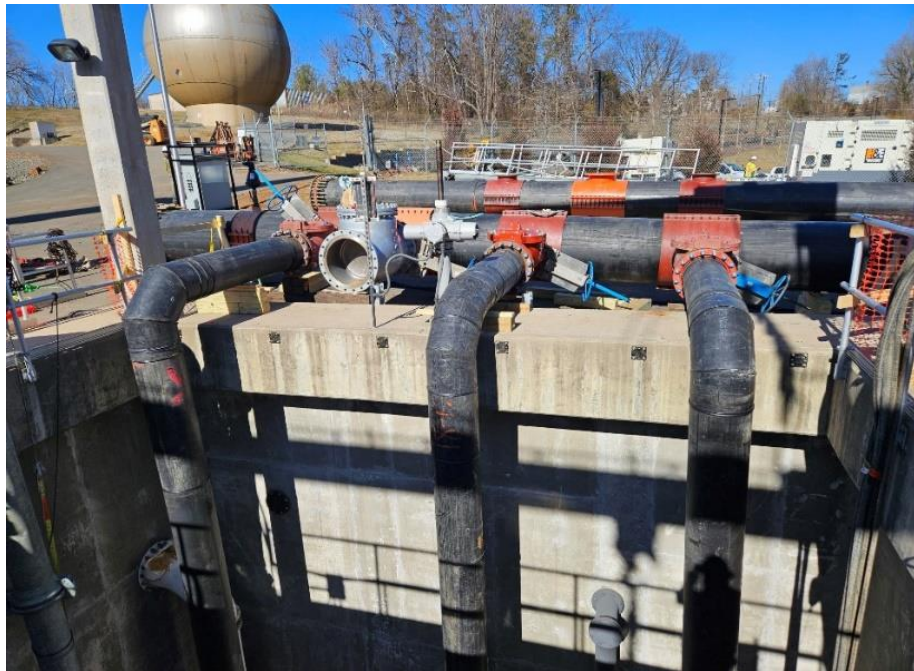
February 5, 2024

50 million gallons per day bypass under construction
